Operating Experience Weekly Summary 97-38

September 12 through September 18, 1997

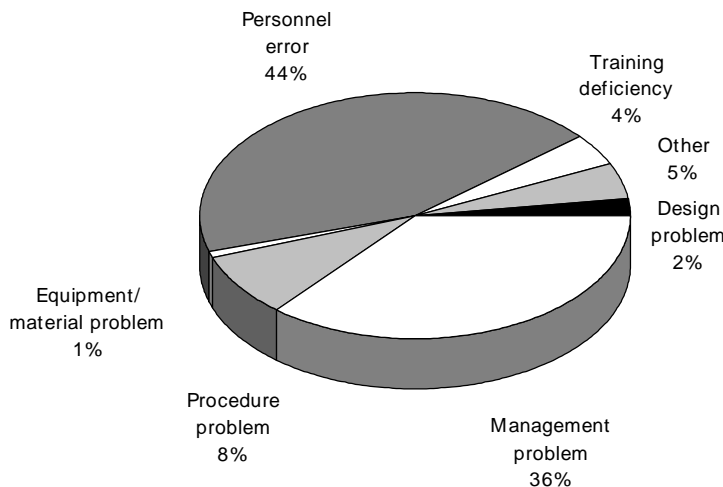
OEAF engineers reviewed the Occurrence Reporting and Processing System (ORPS) database for procedure violations across the DOE complex and found 2,010 occurrences reported from 1995 to present. Figure 1-1 shows that facility managers reported personnel errors as the root cause for 44 percent of the occurrences. They also reported that management problems accounted for 36 percent of the violations. Further review shows that 41 percent of the personnel errors were reported as inattention to detail and 46 percent were reported as procedure not used or used incorrectly.

Figure 1-1. Distribution of Root Causes for Procedure Violations¹

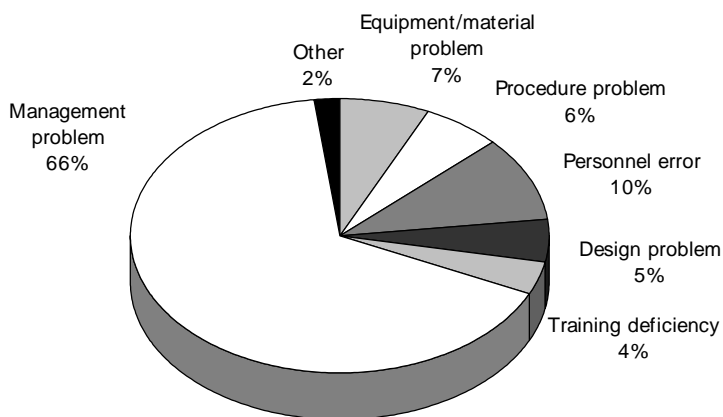
OEAF engineers searched the ORPS database for reports involving contractor work control weaknesses and found 860 occurrences. Figure 2-1 shows the distribution of root causes reported by facility managers for these events. Management problems represented 66 percent of the root causes. Inadequate administrative control accounted for 41 of the management problems, and work organization/planning deficiencies accounted for an additional 31 percent.

Figure 2-1. Distribution of Root Causes for Contractor Work Control Weaknesses¹
